**Investigation of Bond in Unreinforced Concrete Interfaces for Partial
Depth Repairs and New Construction**

Thesis

The University of Texas at Austin

December 2020

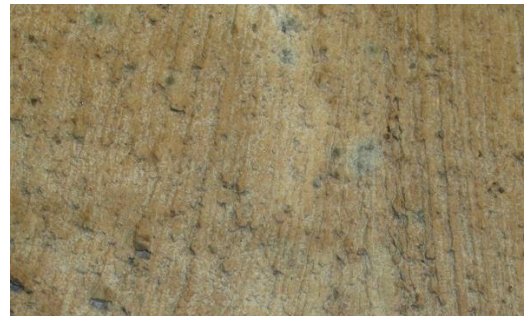
Figure 3-5. Substrate roughened with broom.

The interface conditions were selected to represent common surface preparation practices used in industry. For new precast construction this includes substrates that are smooth (floated), tined (raked), and broomed before the concrete has set. The tining rake profile and its corresponding substrate finish are shown in Figure 3-2 and Figure 3-3, respectively. Likewise, the stiff-bristle broom profile and its corresponding substrate finish are shown in Figure 3-4 and Figure 3-5.

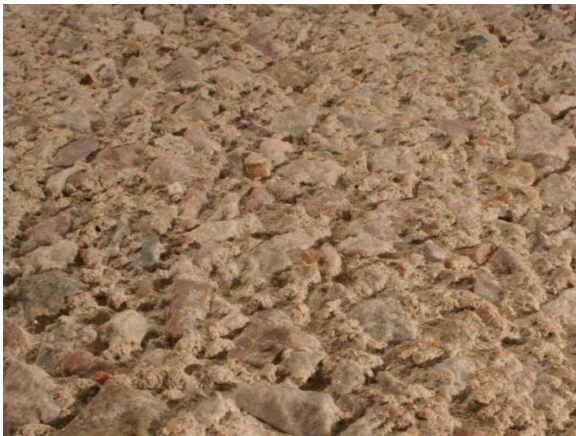
Figure 3-6. Typical repair surface prepared by hydrodemolition (CSP 9-10).

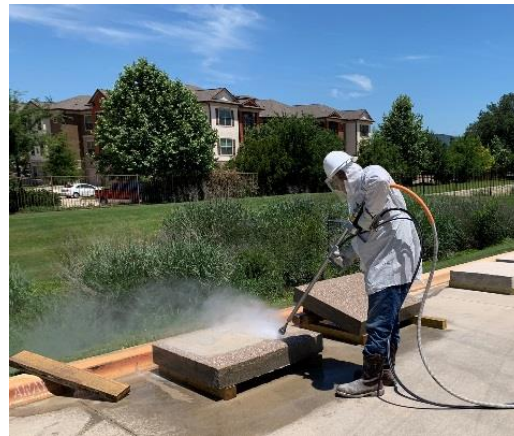
Figure 3-7. Hydrodemolition procedure.

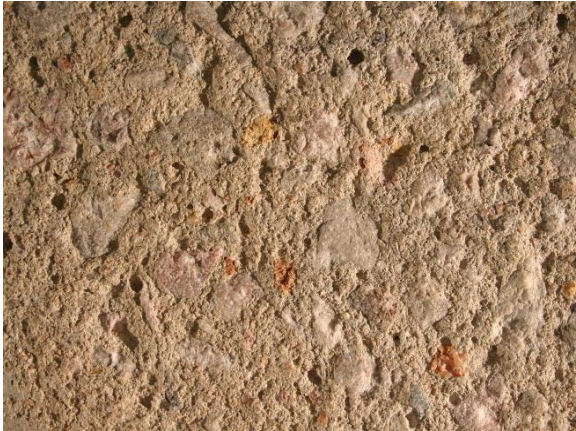
Figure 3-8. Typical repair surface condition prepared by mechanical abrasion (bush hammer followed by sand blasting – CSP 6-7).

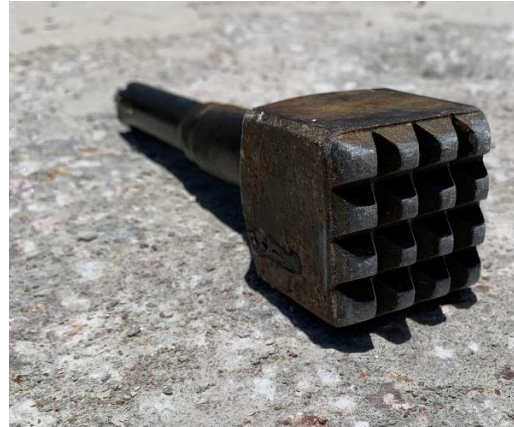
Figure 3-9. Bush hammer bit.

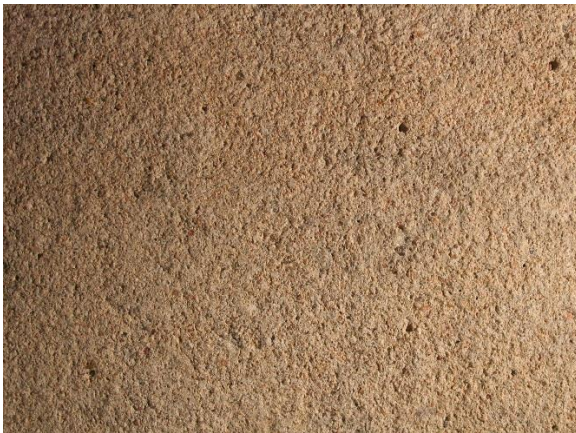
Figure 3-10. Typical repair surface prepared by sandblast only. (CSP 3).

Although sandblasting alone is not a common practice for concrete repair, a range of CSP values was desired for research purposes, and sandblasting was included to provide a lower bound of surface roughness. An experienced repair contractor was engaged to perform the surface preparation by sandblasting, bush-hammering, and hydrodemolition. Photos of each demolition technique are shown in Figure 3-6 through Figure 3-11.

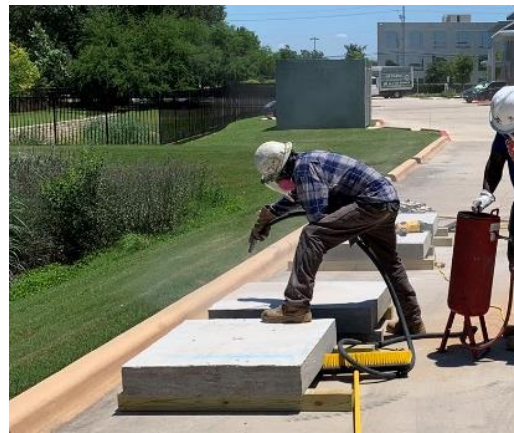
Figure 3-11. Sandblast procedure.

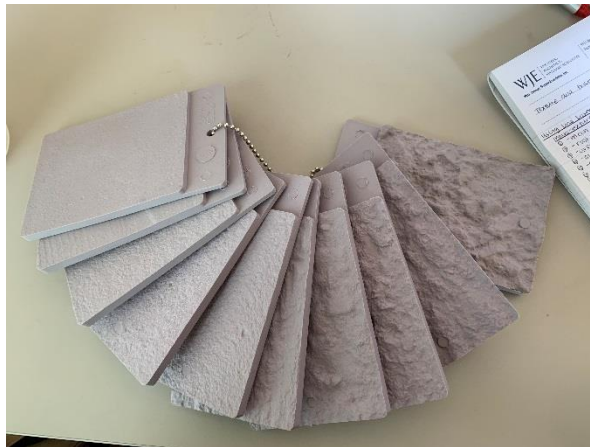
Figure 3-12. ICRI CSP Comparators.

The International Concrete Repair Institute (ICRI) provides a means of visually comparing a concrete surface to 10 concrete surface profiles (CSP) comparators for a qualitative assessment of roughness. The repair specimens were compared to the comparators shown in Figure 3-12.

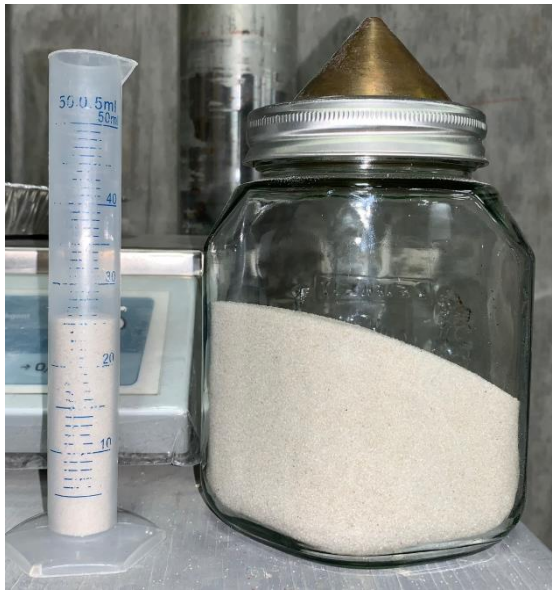
Figure 3-13. Measuring volume of sand for ASTM E965 Sand Patch Test.

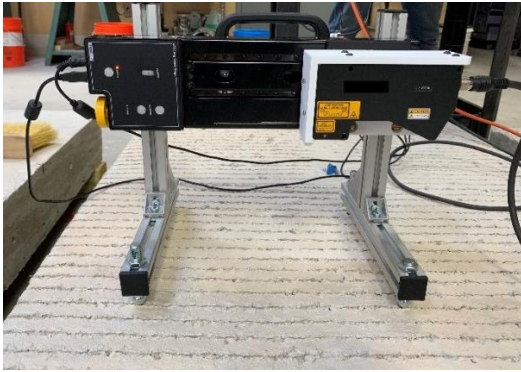
Figure 3-15. Line Laser Scanner on the tined substrate specimen.

The LLS was used in the current study to scan all substrates (precast and repair surfaces). The 3D data were used to calculate equivalent MTD values for each surface condition.

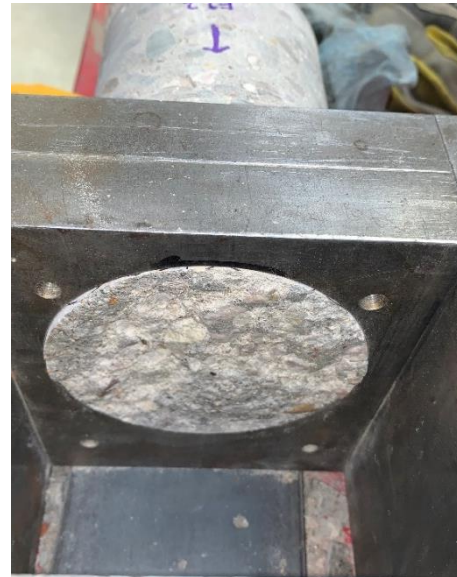
Figure 3-20. Core sample shear failure interface after testing (loading head removed).

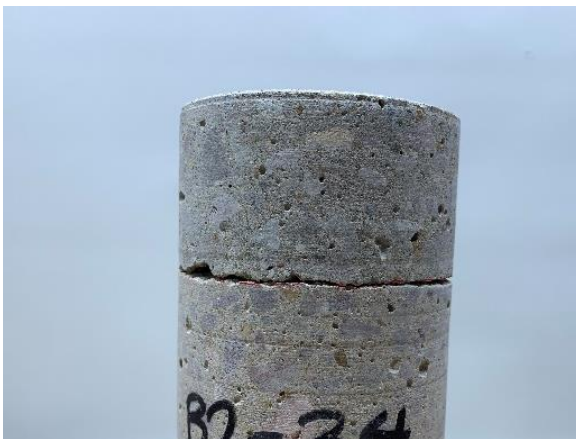
Figure 4-2. Direct shear failure plane at interface bond line (whole specimen).

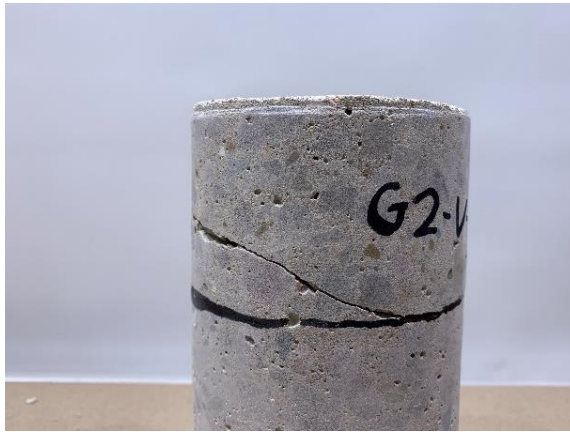
Figure 4-4. Direct shear failure plane propagating into topping layer (whole specimen).

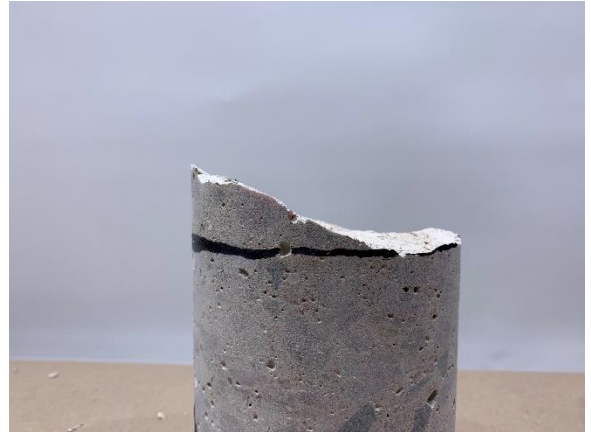
Figure 4-5. Direct shear failure plane propagating into topping layer (only substrate portion of core shown).

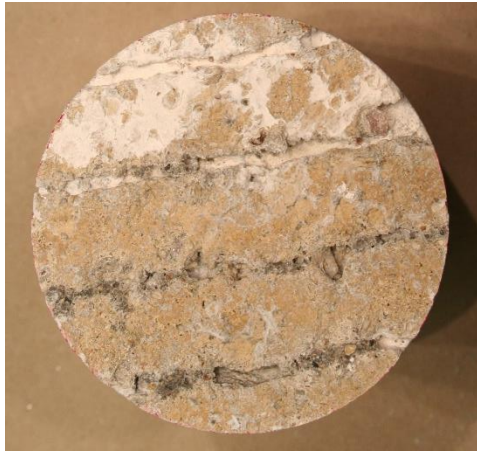
The difference between the workability levels and placement techniques was visibly apparent at the bond interface observed after testing, as illustrated in Figure 4-6. Incomplete consolidation of the topping against the substrate concrete was visibly apparent in specimens with lower slump topping placed by screed only. Where moderate slump topping was consolidated by hand or vibration, instances of entrapped air or incomplete consolidation at the interface were significantly reduced. In addition, filling of tine grooves in the substrate by the topping was improved such that the groove lines were much less visible after testing to failure.

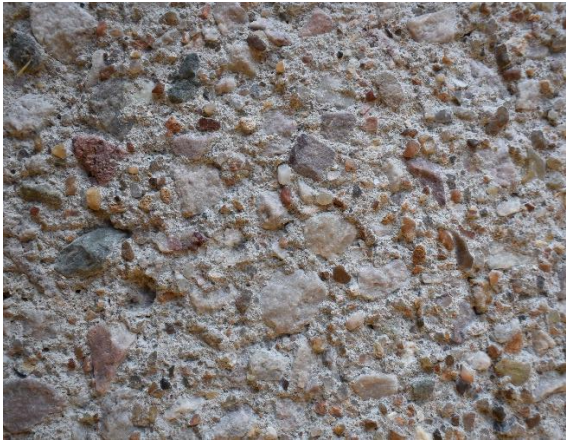
Figure 5-1. Hydrodemolition

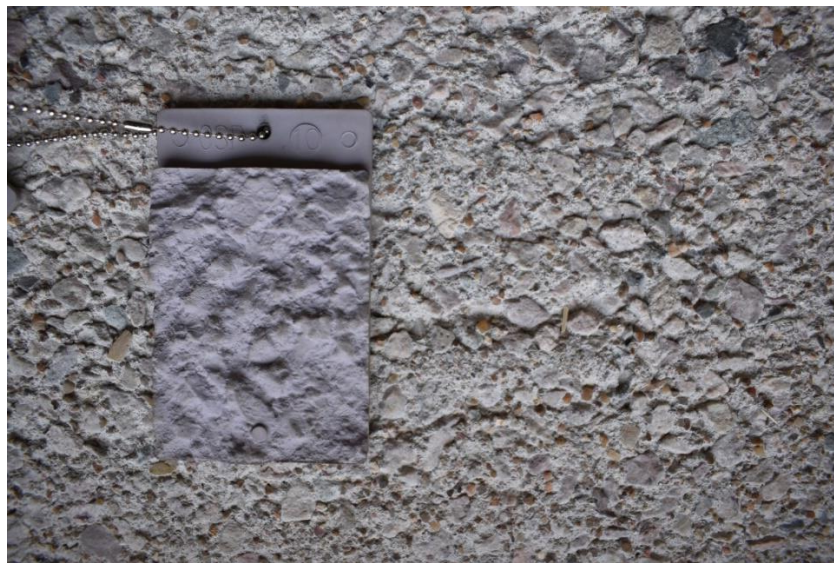
Figure 5-10: Hydrodemolition compared to CSP 10 comparator.

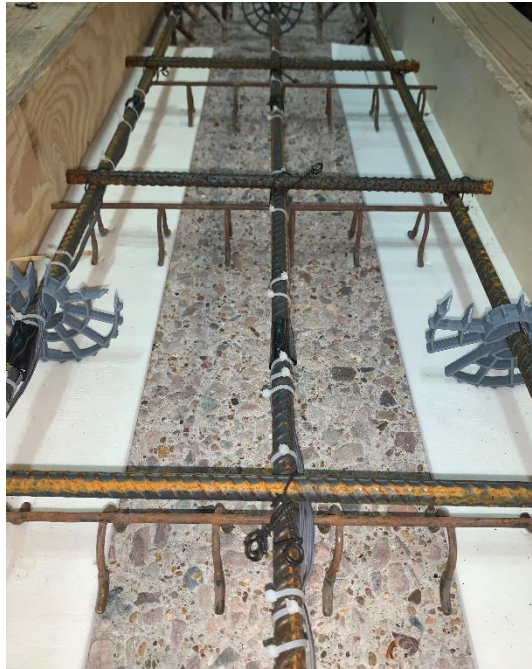
Figure 5-12: Hydrodemolition substrate with debonding foam tape.

As previously described, the failure end of the interface of composite beams was partially debonded to enforce a horizontal shear failure. A variety of techniques have been used in previous studies to debond portions of concrete interfaces, including plastic wall paneling secured with tape (Swan 2011) and polyethylene foam tape (Kovach and Naito 2008). The debonding material needs to be thick enough to prevent aggregate interlock between the substrate and topping, but also be flexible to adhere to the peaks and valleys of each surface so that it stays in place during casting. In the present study, one layer of 1/4-inch polyethylene foam tape was chosen as the debonding material. Figure 5-12 shows the debonding tape installed on the hydrodemolition beam substrate. Prior to the beam casting, the effectiveness of the debonding foam tape was tested on mock-up cylinders with roughened surfaces. The roughened substrate of the mock-up was covered by the foam tape and a topping was cast on top of the foam tape. Once the forms for the topping were removed, the concrete topping could be easily pulled off due to self-weight.

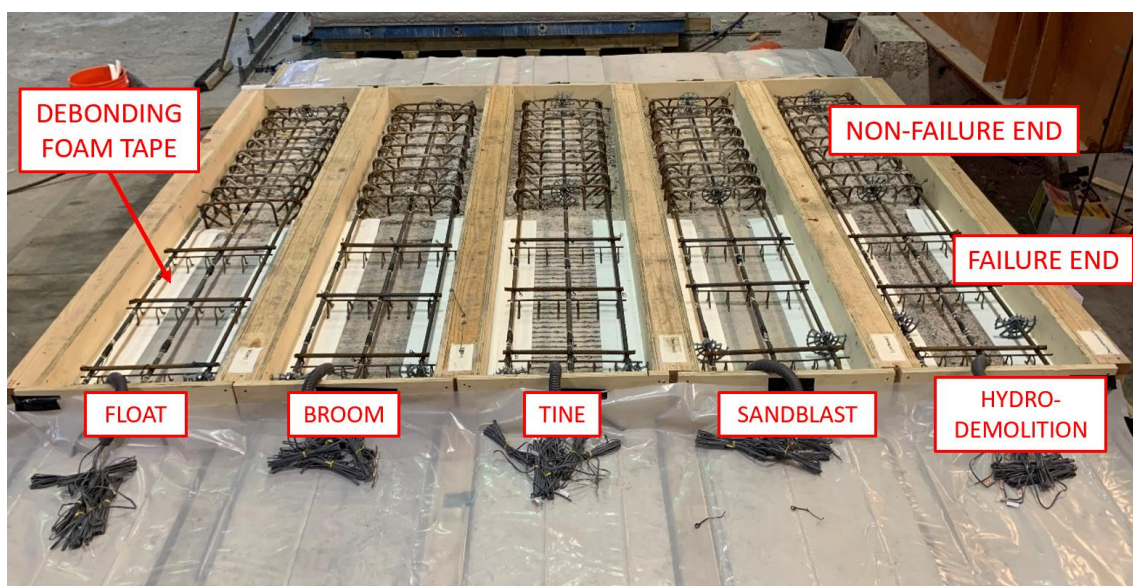
Figure 5-13: Beams ready for topping pour.

The concrete toppings for the composite beams and slabs were cast at the same time. The beams specimens prior to the topping pour are shown in Figure 5-13. Prior to casting, the substrates were covered with saturated burlap and left to soak for 24 hours to achieve SSD conditions (Figure 5-14). Before the concrete arrived for the topping the surfaces were cleaned and patted dry. Any water puddles were blown with compressed air. The same mix design that was used for the substrates was used for the topping.

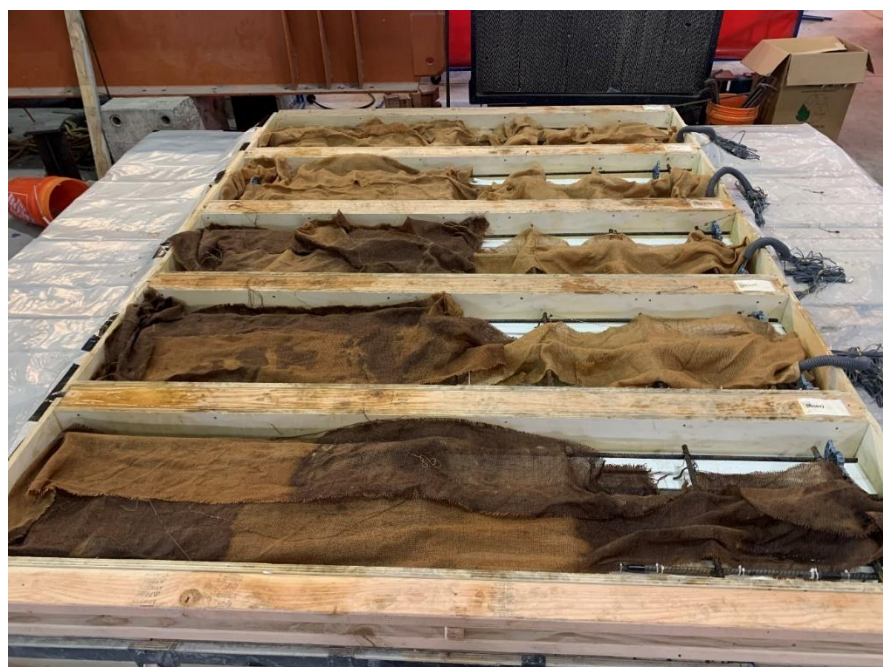
Figure 5-14: Soaking substrates before casting to achieve SSD conditions.

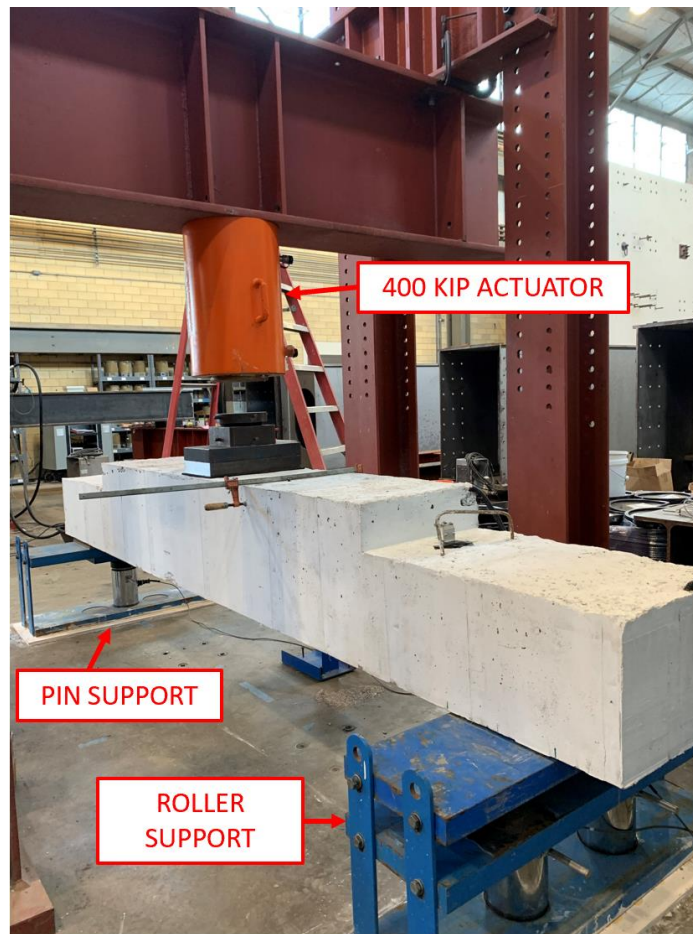
Figure 5-15: Beam test setup.

The beam was loaded under monotonic loading using a hydraulic pump. The load was applied at 10-kip increments. At the end of each load increment, the test was paused and the beam was examined for cracks.

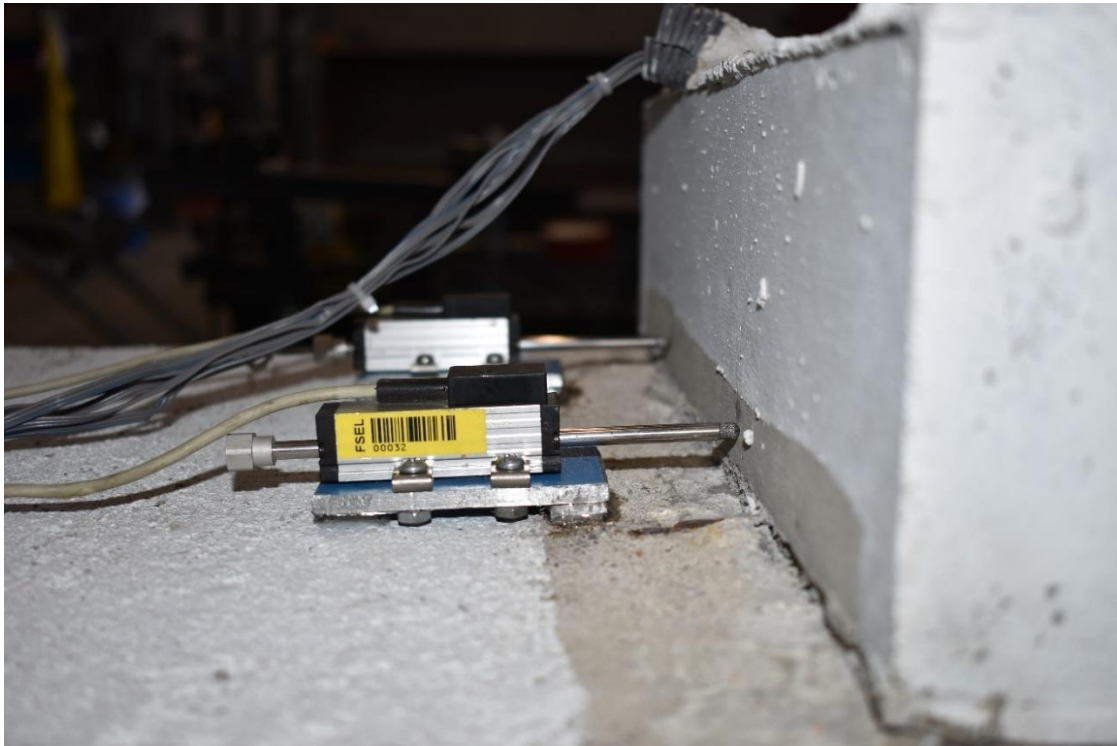
Figure 5-20: End-slip linear potentiometers.

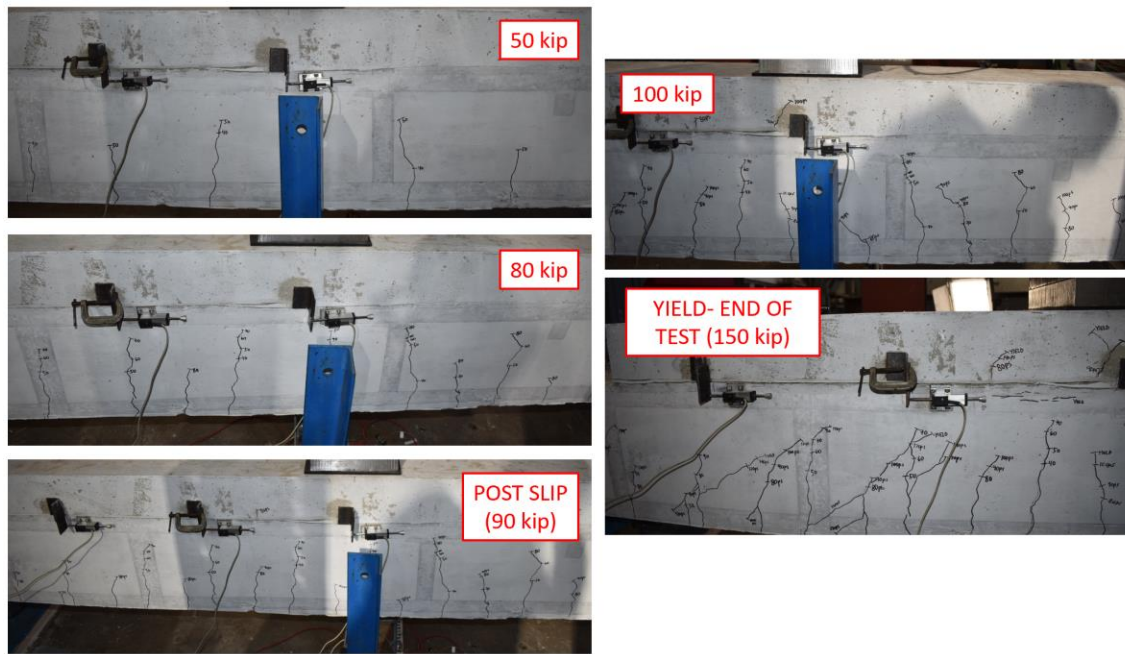
Figure 6-5: Crack progression of hydrodemolition beam.

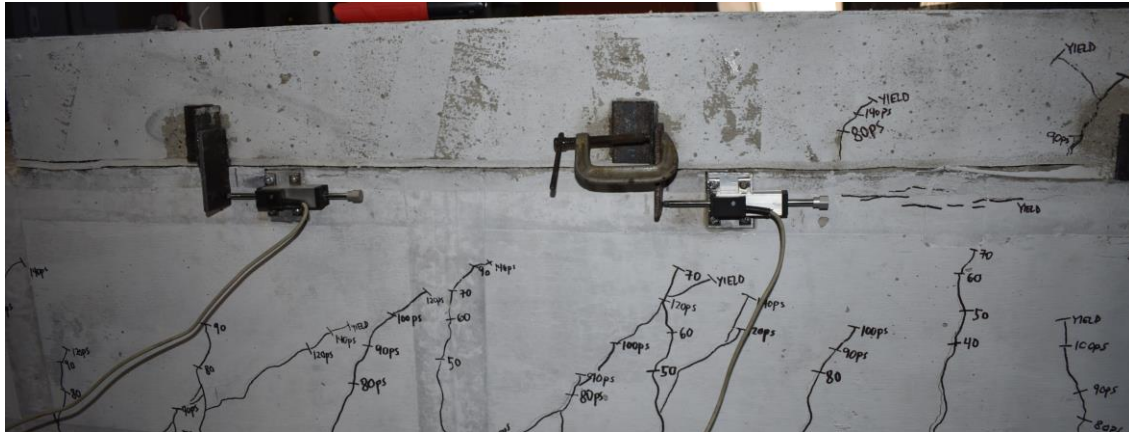
Figure 6-9: Top of substrate concrete crushing at midspan when tension steel yielded.
Vertical gap seen between topping and substrate on left side of photo.
